Manhole Inspection Summary

Manhole # S11GG2015MH

Insp Date: **7/7/06 3:29 PM**

Location Address: **2330 BRIGHT LEAF WAY**

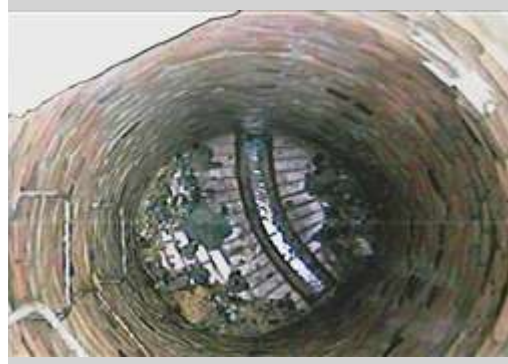
Top View

☒ **Evidence Of Surcharge**

Evidence of surcharge - Bench debris.

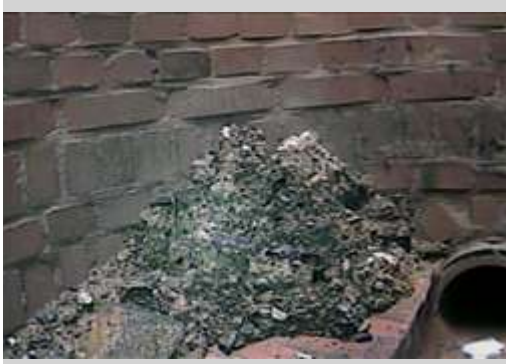
Defect

Infiltration: ☐ None ☐ Joint ☐ Cracks ☒ **Mortar** ☐ Roots ☒ **Wall**

Condition: ☐ Sound ☐ Cracked ☐ Root Intrusion ☐ Deteriorated ☐ Leaks ☒ **Debris**

Barrel infiltration. Bench debris.

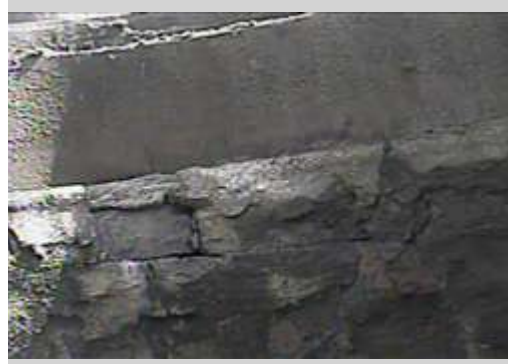
Defect

☒ **Leaks**

Condition: ☐ Sound ☐ Cracked ☐ Root Intrusion ☐ Loose Brick ☒ **Deteriorated**

Infiltration: ☐ None ☒ **Joint** ☐ Cracks ☒ **Mortar** ☐ Roots ☐ Wall

Frame leaks. Adjustment deterioration and infiltration.

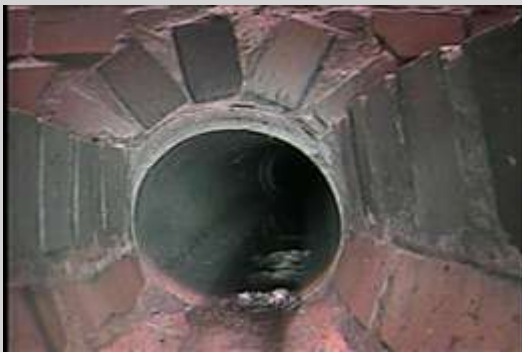
8 in. Circular Gravity Sewer Pipe Out @ 12 O'Clock

Deposits: ☐ None ☐ Mud ☐ Sludge ☒ **Debris** ☐ Grease

Infiltration: **Evidence** Pipe Seal Cond: **Unknown**

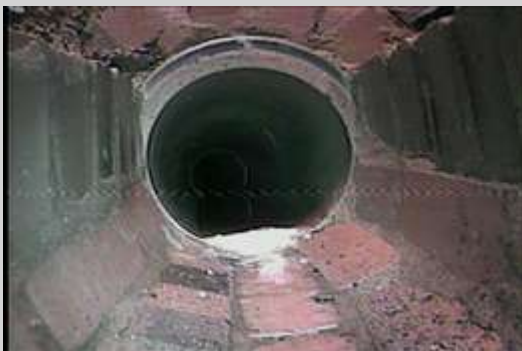
8 in. Circular Gravity Sewer Pipe In @ 5 O'Clock

Deposits: ☐ None ☐ Mud ☐ Sludge ☒ **Debris** ☐ Grease
